TECHNICAL MEMORANDUM

RE: Gulfco Marine Maintenance Superfund Site – Site Visit on September 26, 2005 following Hurricane Rita

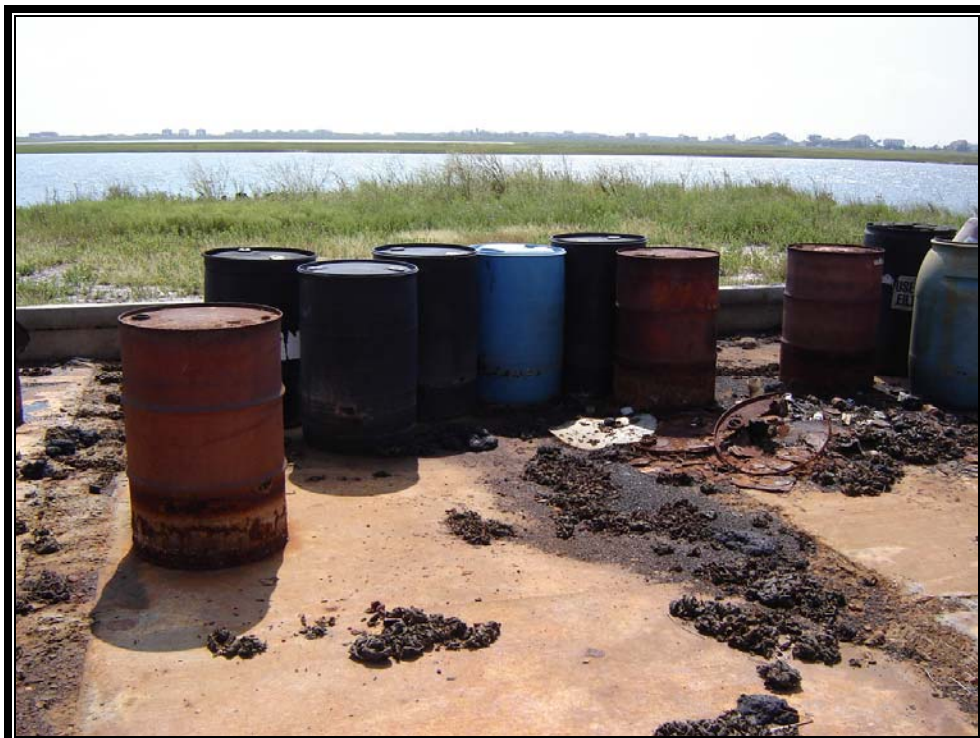
Upon arrival at the Site, there were no indications that storm surge or high winds had occurred at the Site. Compared to the July 20, 2005 site visit, there did not appear to be any more or less debris at the Site. Comparing photographs taken during the July 20, 2005 site visit, ten 55-gallon drums located on the south end of the AST containment area appeared to be in the same position during this visit (Photo Nos. 1 and 2) with the drums still in the upright position. Using the OVM calibrated to 100 parts per million vapor (ppmv) isobutylene, I walked around each of the ASTs shown on Figure 1 to collect readings that could indicate a potential leak. With the exception of AST Nos. 14 and 16, OVM readings were collected around all sides of the tanks. About 1 foot of standing water was observed on the west side of AST Nos. 14 and 16 within the containment area, and the footing in the area presented a potential slip/trip/fall hazard. Therefore, OVM readings were not collected next to the tank on the west and north sides, but readings were collected on the north and east sides of AST Nos. 14 and 16. An OVM reading of the standing water in this area was collected with a reading the same as background (0.0 to 0.1 ppmv). OVM readings were generally collected within a foot of the ASTs at about 2 feet above the ground surface.

PHOTO NO. 1 – Drums in southern end of AST containment area, looking south.

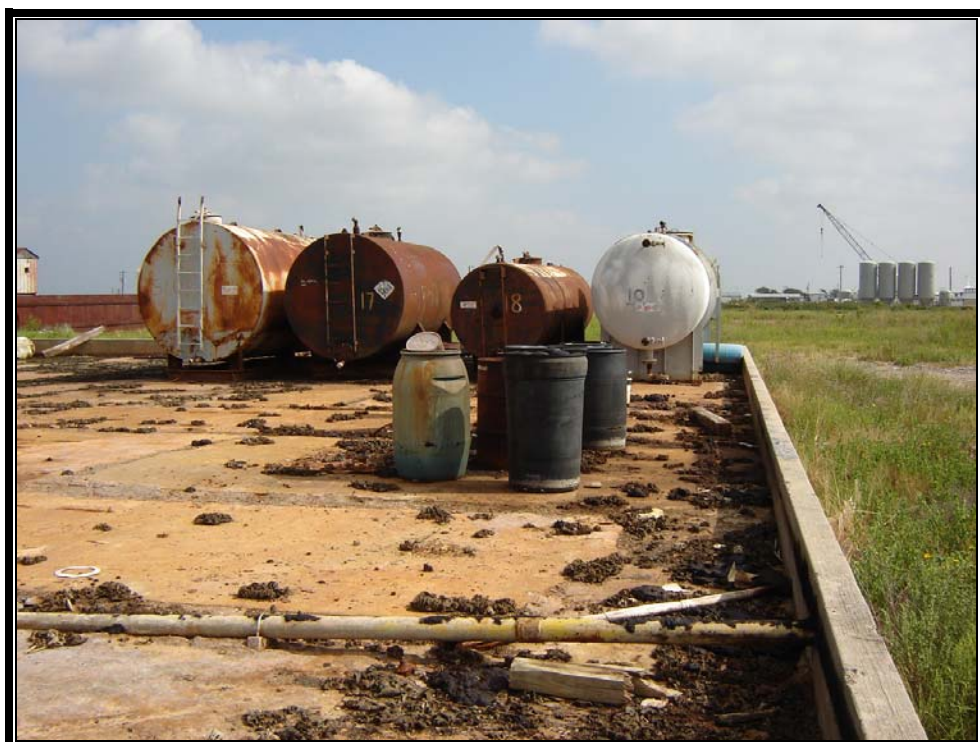
PHOTO NO. 2 - Drums in southern end of AST containment area, looking east.

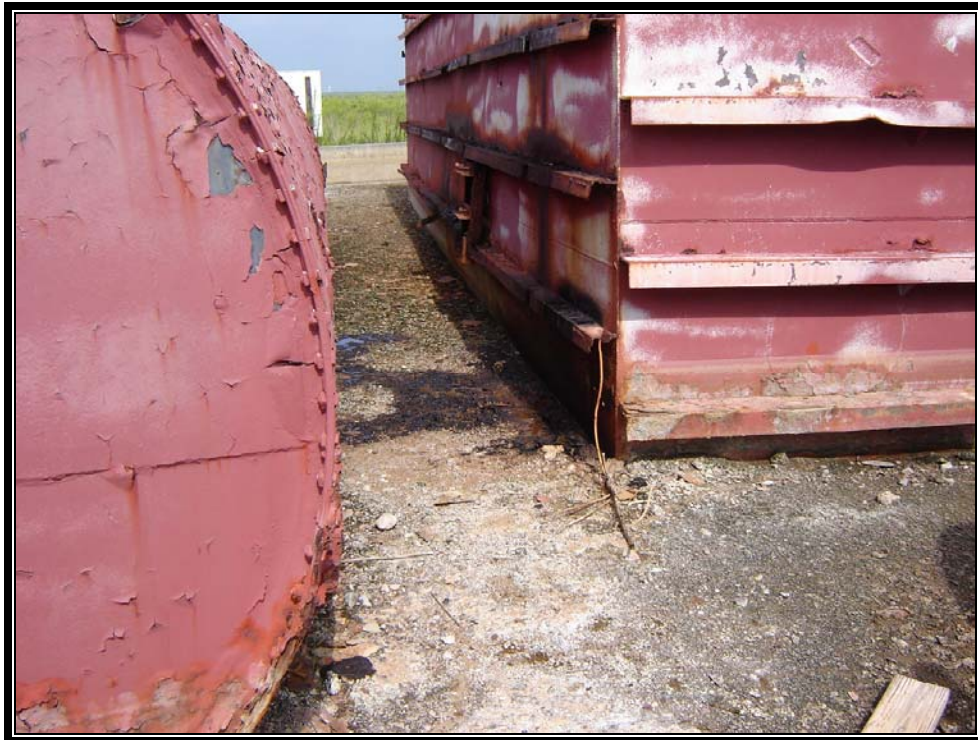
None of the tanks appeared to have any damage associated with the storm. A small leak was observed on the southwest section of AST No. 6 with a slow drip where the side of the tank had some signs of rust (Photo No. 3). This tank was identified as containing iron flakes and water (from LTE Site Characterization Report, Table 2, 1999). On the ground near the leak in AST No. 6, there was some sludge material observed. The OVM reading immediately above the material was 0.3 ppmv. A small leak was also noted on the northeast corner of the tank (Photo No. 4). There were no OVM readings greater than 0.0 ppmv around AST No. 6.

PHOTO NO. 3 – View of AST No. 6, small leak on southwest portion of tank, looking northwest.

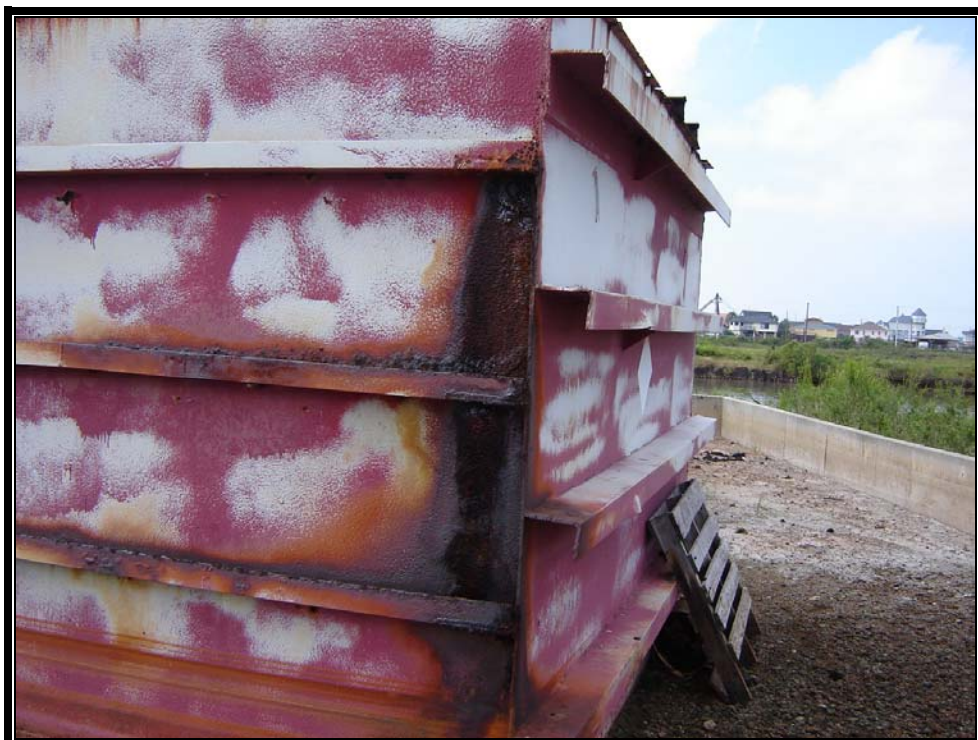
PHOTO NO. 4 – View of AST No. 6, small leak on northeast corner of tank, looking south.

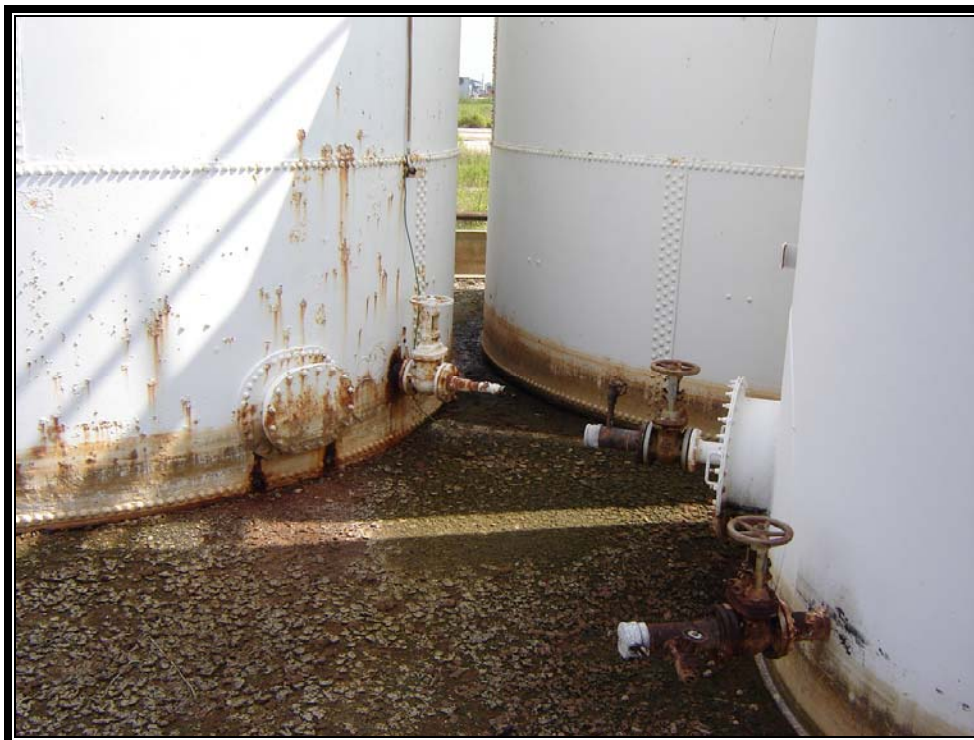
AST No. 21 had a small leak noted at the clean-out flange on the southwest side of the tank (Photo No. 5). No organic vapors were detected near this tank with the OVM (OVM reading of 0.1 ppmv, checked background, also 0.1 ppmv). No other leaks were observed in the two other large ASTs in this area (AST Nos. 15 and 19). The OVM readings around the three tanks were less than 0.1 ppmv.

PHOTO NO. 5 – View of AST Nos. 21 (left), 15 (center), and 19 (right), note small leak on AST No. 21, looking northeast.

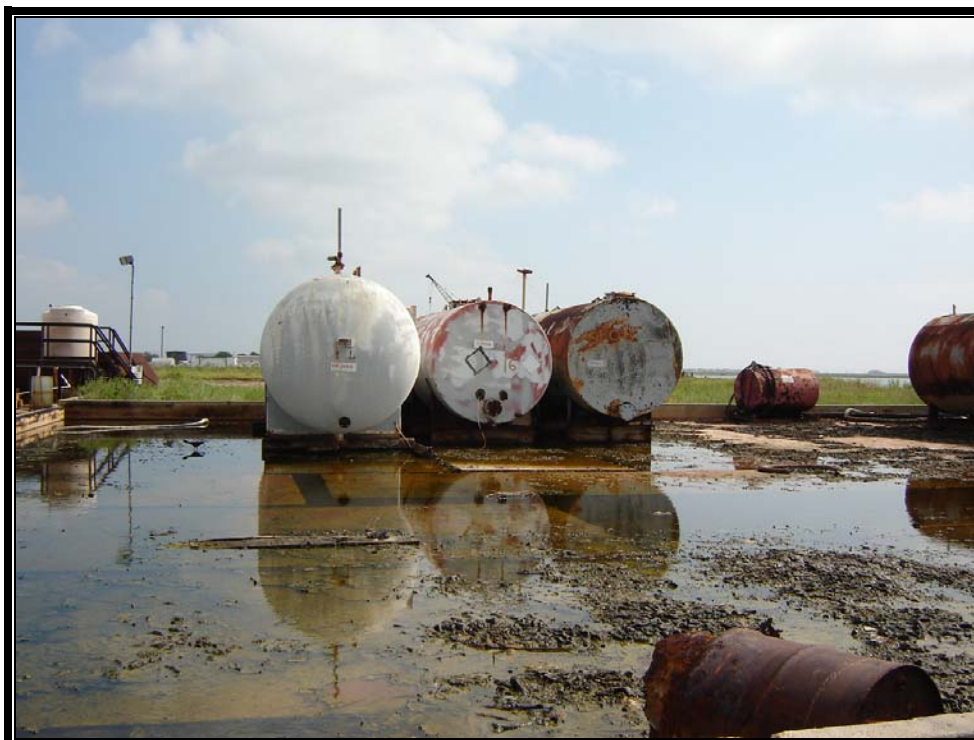
None of the eight ASTs (AST Nos. 10, 13, 14, 16, 17, 18, 22, and 23) (Figure 1) in the south containment area had any signs of damage or leaks. AST Nos. 13, 14, and 16 were in standing water (Photo No. 6) with no observable sheen on the water. As previously mentioned, there were no organic vapors detected from this standing water or from the tanks. AST Nos. 10, 17, 18, and 22 were in a dry portion of the containment area (Photo No. 7). No organic vapors were detected near these tanks. A slight odor was noted immediately downwind of AST No. 17 (Photo No. 8) with the OVM reading 0.3 ppmv (just above the background reading of 0.1 ppm). However, the odor and the OVM reading were not consistently detected. It appeared that the odor may have been from a port on top of AST No 17 that may allow some release of vapors when the fluids in the AST expand from the heat of the day. By this point of the site visit, the temperatures had risen well into the 90's.

PHOTO NO. 6 – View of AST Nos. 14 (left), 16 (center), and 13 (right), looking northeast.

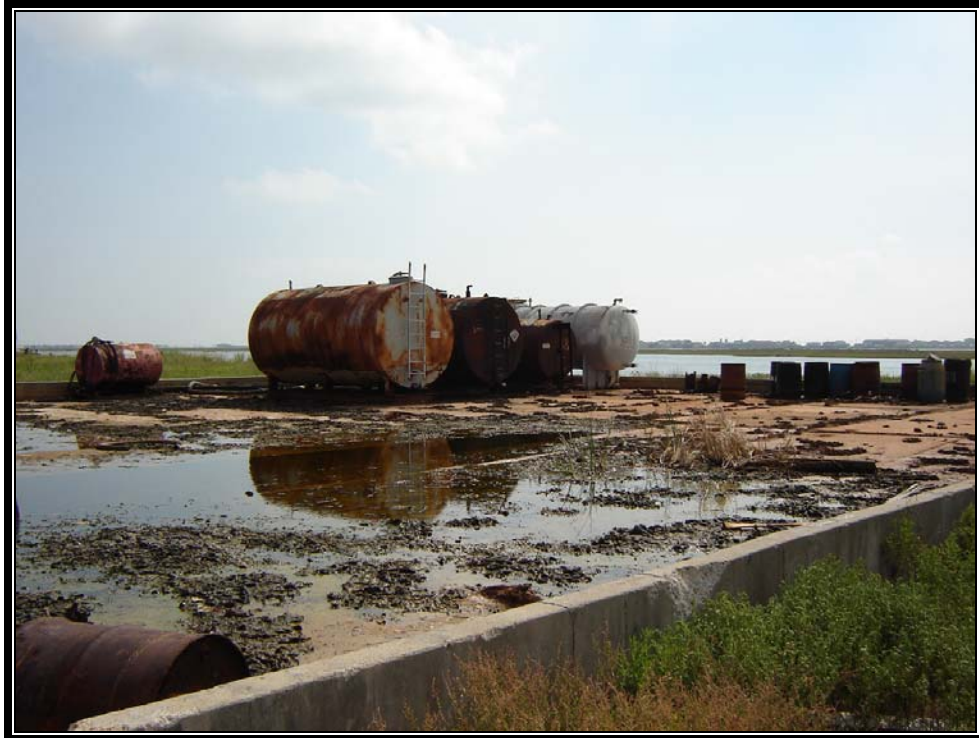
PHOTO NO. 7 – View of AST Nos. 22 (left), 17 (left center), 18 (right center) and 10 (right), looking east.

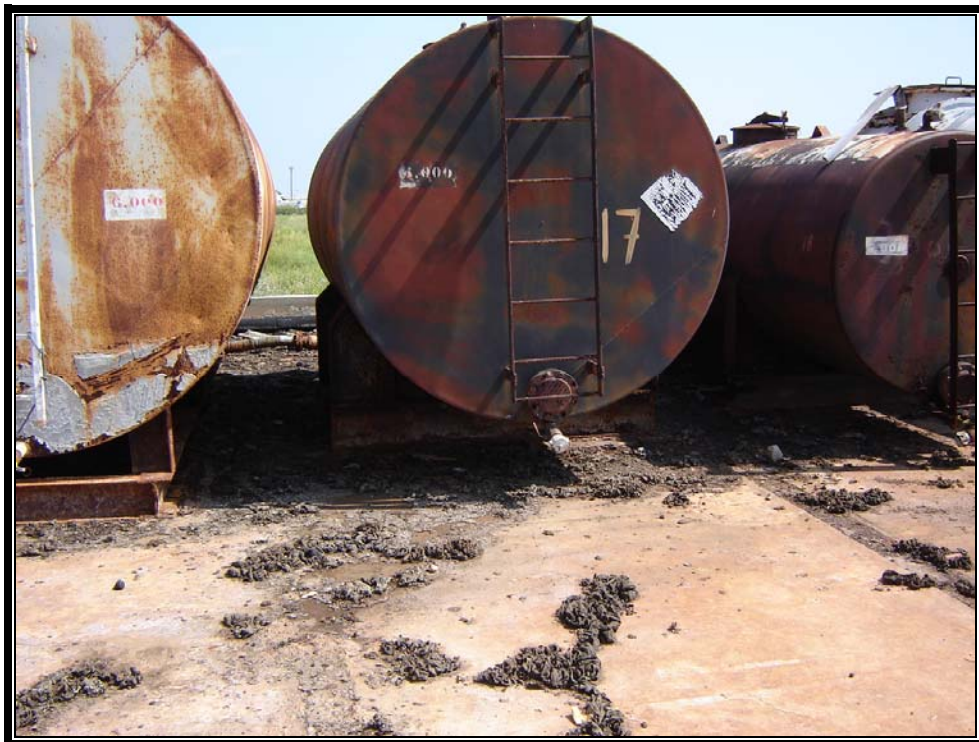
PHOTO NO. 8 – View of AST No. 17, looking northeast.
